## MCE TECHNICAL BULLETIN

Reference # 154

**Subject** Potential loss of motor control due to power supply failure, IMC-SCR.

**Equipment** IMC-SCR & IMC-Performa Controllers.

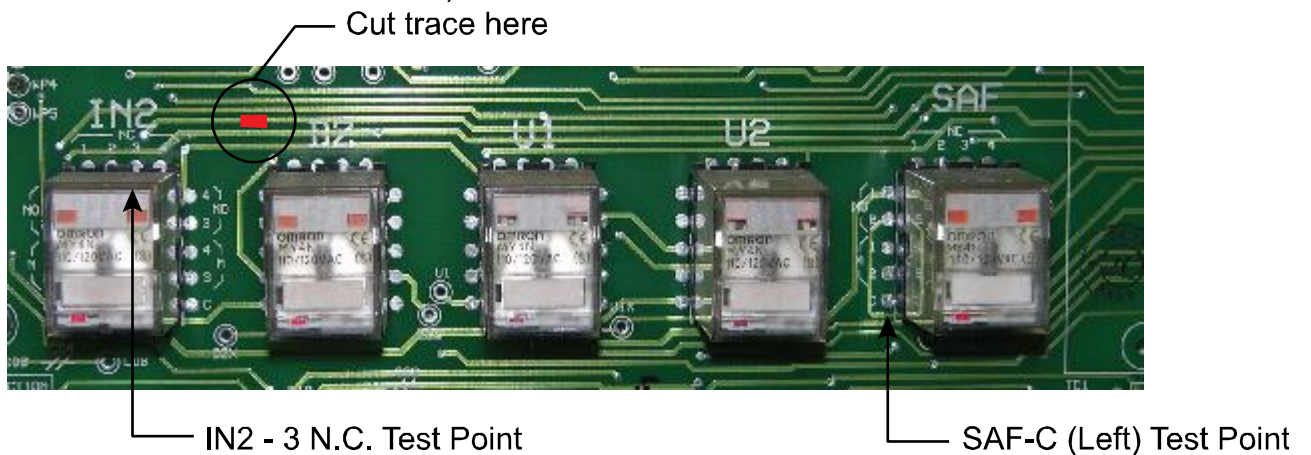
**Figure 1**

**Description** It has been brought to MCE's attention that if the voltage level of 5 volt power supply feeding the controller computer (swing panel) falls below regulation, it can have adverse effect on the operation of the motor control. In certain situations, the elevator computer may become inoperable and motor field voltage can drop to zero. Having very low or no motor field control can result in the car drifting in the direction of the load due to lack of torque control. **This scenario is only applicable to inspection operation.** Automatic and passenger operation use additional software monitors and are not affected.

1. Power down the controller.
2. Using the resistance setting on a digital multimeter, confirm there is continuity between IN2-3 N.C. and the left-hand coil connection on the SAF relay using the relay test pads, which you can see in Figure 1 below.
3. With power still off to the controller, locate the trace that connects to the via just above the IN2-3 N.C. contact on the HC-RB4-SCRI-C board, and make a clean cut on that trace as indicated below:

4. Confirm that there is no continuity between the two points measured in Step #2 above.
