# Harmonic Analysis and Comparison

- **SYSTEM 12** - 12 Pulse SCR Elevator Drive
- Conventional Six Pulse Elevator Drive
- Flux Vector VFAC Elevator Drive
- Includes Supplemental Jobsite Analysis

**Motion Control Engineering, Incorporated**

*This Technical Publication reports analysis and comparison of AC line harmonic distortion produced by three modern static drive types.*

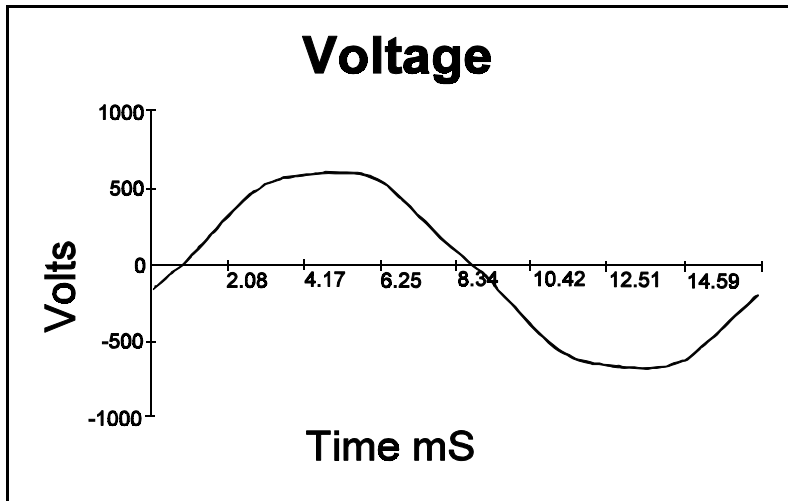
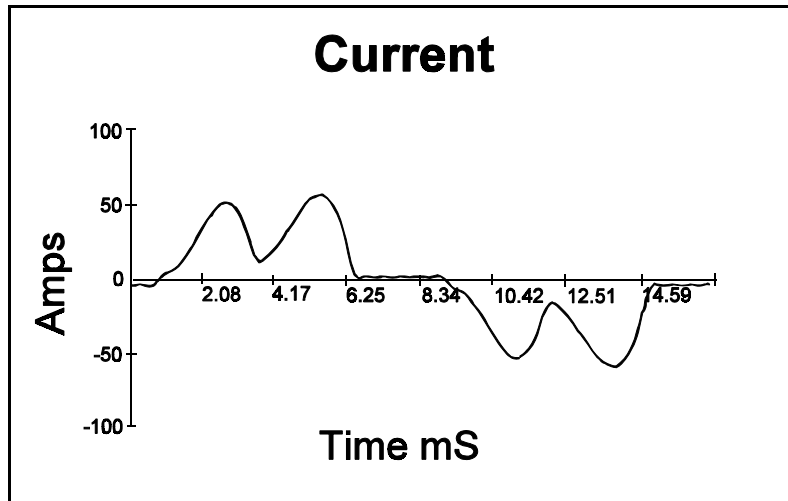
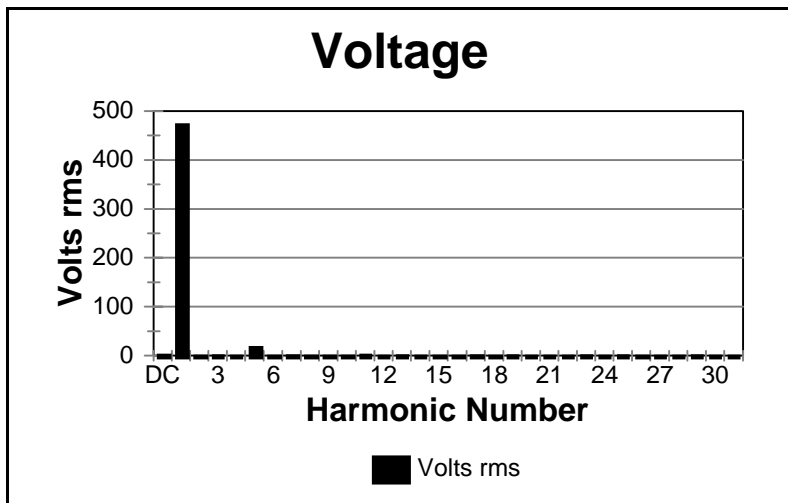
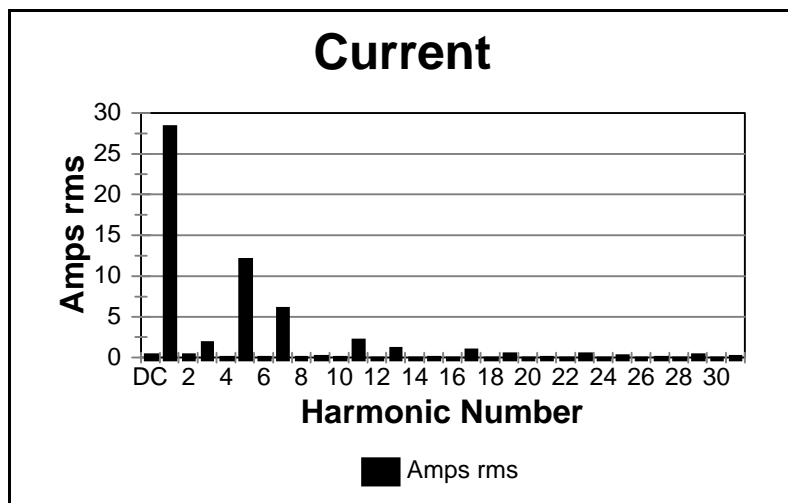
# Yaskawa Flux Vector VFAC Drive

MCE test tower data; 350 fpm, 20 HP AC motor, full load up acceleration. Ideal voltage and current should be illustrated as perfect sine waves. Fifth and seventh current harmonics are severe. The voltage waveform peaks are “flattened” unlike either SCR drive.

The voltage waveform for the VFAC drive has a noticeable flattening at the top and bottom. The VFAC drive visibly distorted the voltage sine wave, which is not easy to do -- the AC line for the MCE test tower elevator is very stiff.

Examination of the shape of the current waveform reveals the real story insofar as line distortion being generated by the VFAC drive is concerned. The waveform depicts how the VFAC drive draws current from the AC line. The current sine wave is obviously distorted. The VFAC is clearly the **worst** of all three drive types, a surprise considering the previously acknowledged superiority of AC technology in the elevator industry. The tests were repeated numerous times to verify that these figures were correct. Review of published literature corroborates findings -- suggesting that test results are typical.

Consider the bar graphs showing the relative magnitude of current harmonics. The fifth harmonic is nearly half the magnitude of the first harmonic. The first harmonic is actually the 60 Hz fundamental -- in the hypothetical ideal power system it would be the only bar illustrated.

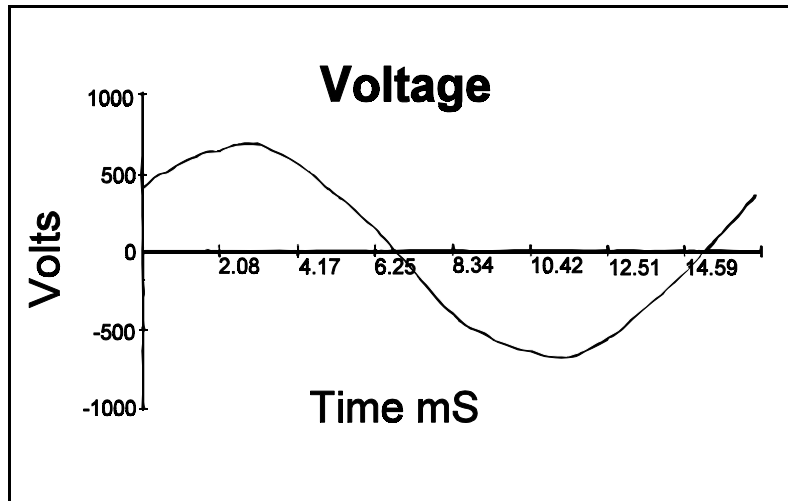
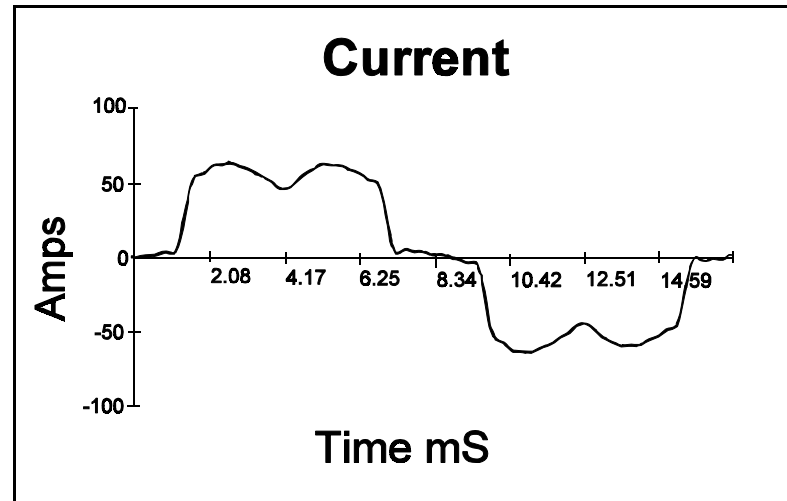
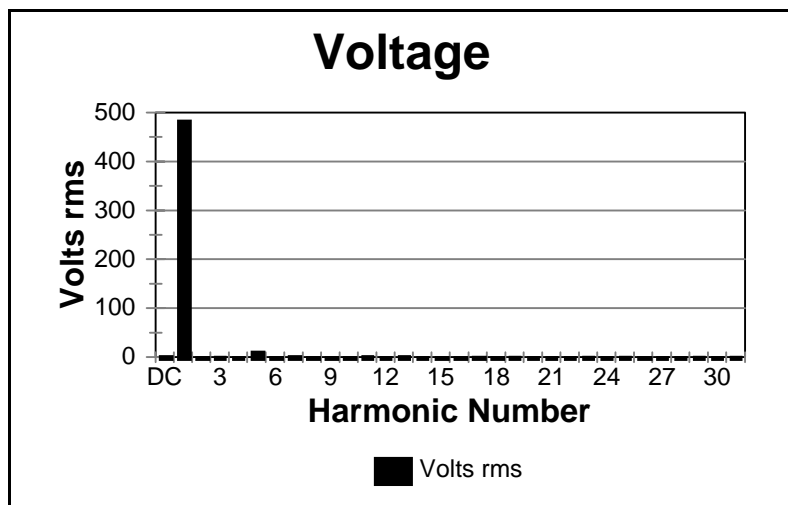
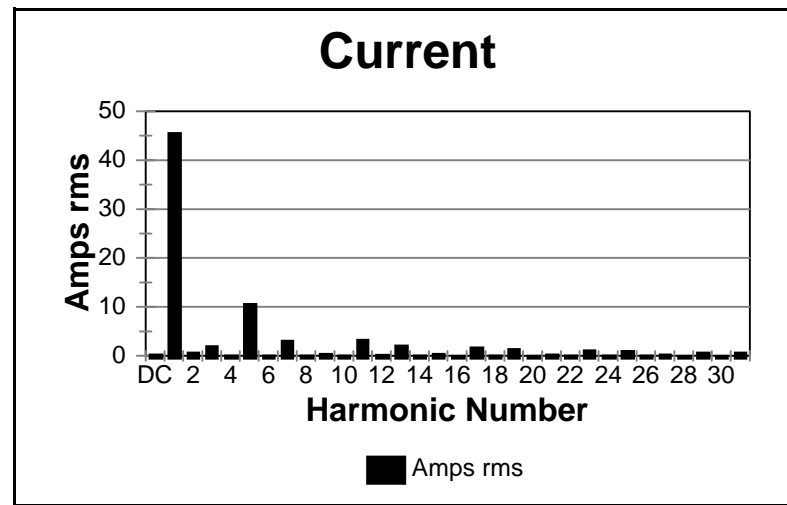
## Conventional 6-Pulse DC SCR Drive

Data taken from MCE test tower; 350 fpm, 20 HP DC motor, full load up acceleration. Ideal voltage and current should be illustrated as perfect sine waves. Note that the largest current harmonics are the fifth and seventh. This data is typical and would be identical for a 6-pulse SCR drive of any manufacturer.

The voltage waveform doesn't provide much information because it is very close to a sine wave. This is confirmed by measured Voltage Total Harmonic Distortion of 2.6% (THD Rms under the Voltage column). Also note voltage harmonics are almost invisible on the bar graphs.

Examining the current waveform you can see that it is an improvement over the VFAC drive, but it is still only a rough approximation of a sine wave. Current harmonic distortion is apparent.

For a 6-pulse DC SCR drive, the main harmonics are five, seven, eleven, thirteen and so forth. These are the same significant harmonics as those in the VFAC drive. This is explained by the fact that the typical VFAC drive can be considered a 6-pulse system.

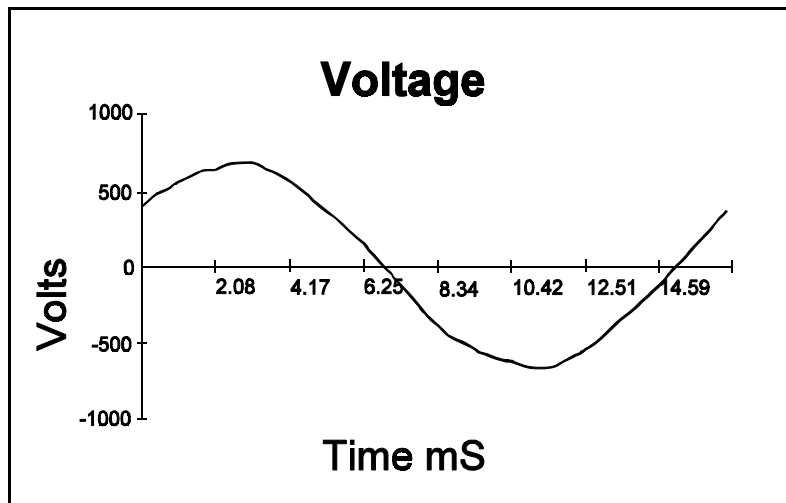
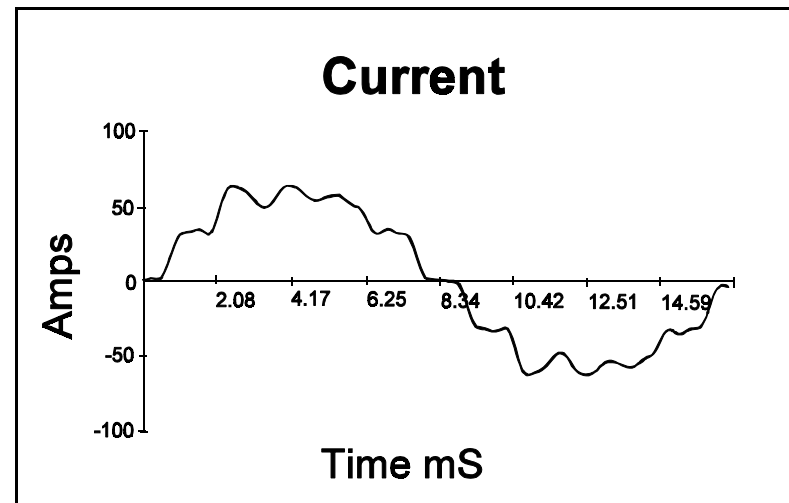
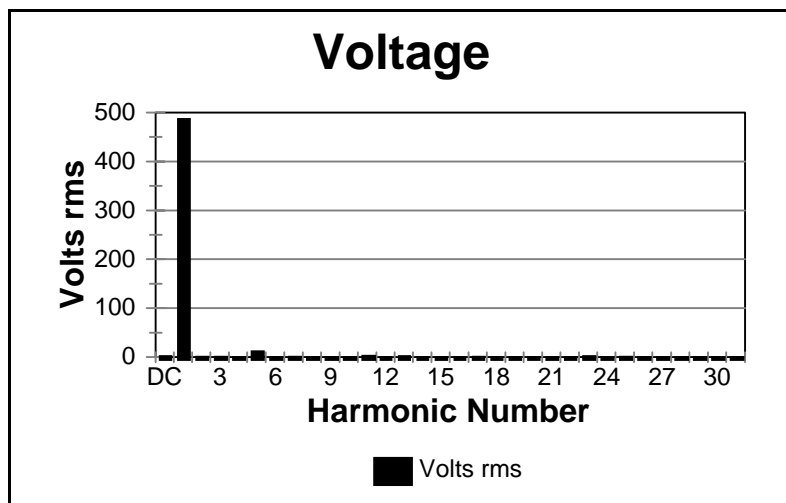
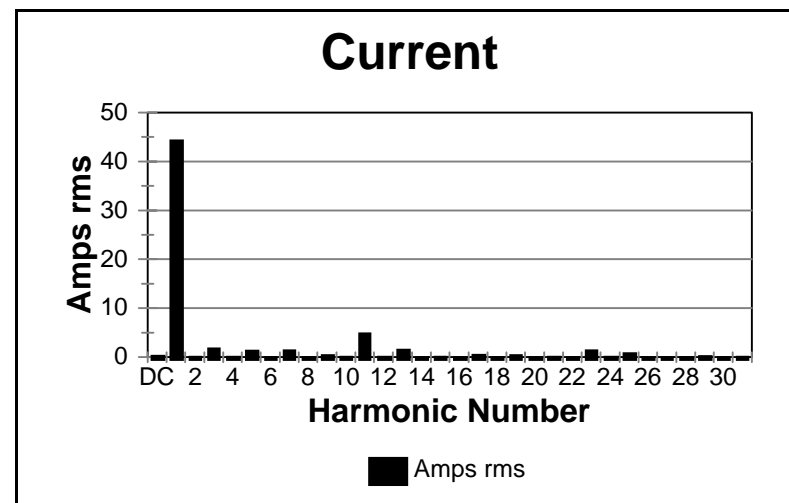
## 12-Pulse SCR Drive (MCE's "System 12")

Data taken from MCE test tower; 350 fpm, 20 HP DC motor, full load up acceleration. Ideal voltage and current should be illustrated as perfect sine waves. Note that the largest current harmonics are the eleventh and thirteenth.

As expected, the voltage waveform doesn't reveal much information because it so closely approximates a sine wave. The Voltage Total Harmonic Distortion confirms this, measured at only 2.6%, equal to the 6-pulse DC SCR drive.

The bar graph illustrating voltage harmonics appears identical to the 6-pulse DC SCR drive, but this is misleading. The AC line is very stiff and hard to effect. Further, the graph represents residual distortion on the line, not the effect of the 12-pulse DC SCR drive.

The *SYSTEM 12* current waveform more closely resembles that of an ideal sine wave than either waveforms for the 6-pulse DC SCR or VFAC drives. The 12-pulse waveform shows significant improvement over the other two drive types.

When the **current** harmonics are examined, one can see they are **greatly reduced** in comparison to the other drive types. The significant harmonics for the 12-pulse drive are 11, 13, 23, 25 and so forth.

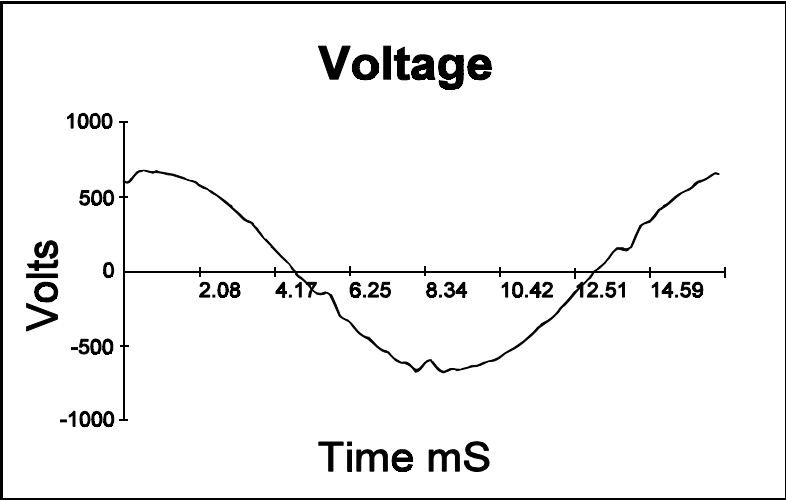
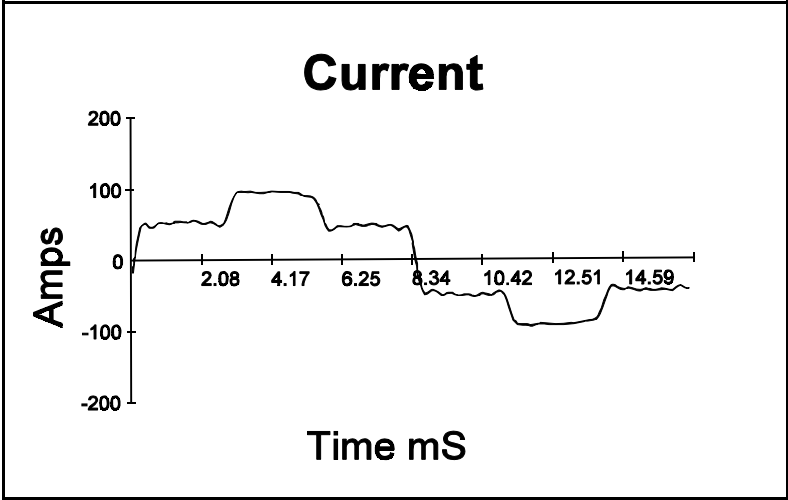
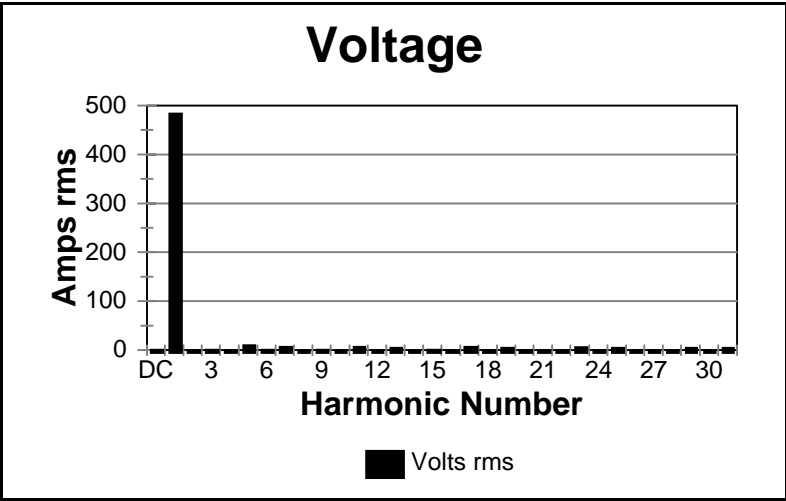
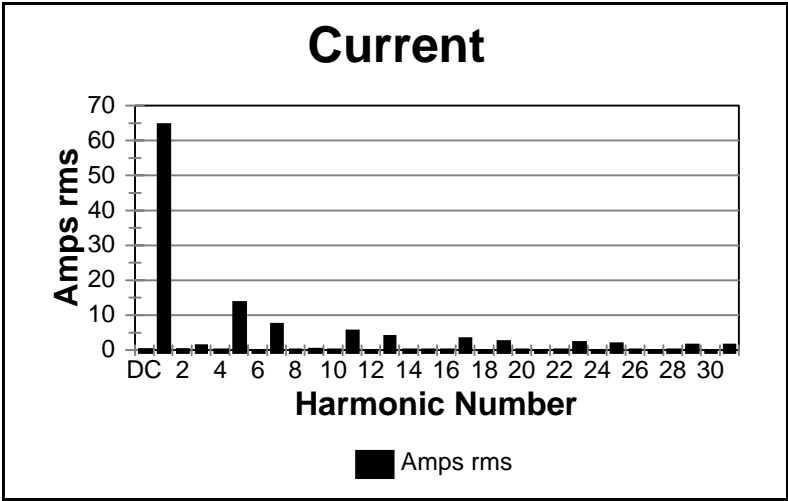
# Conventional 6-Pulse DC SCR Drive

Data taken from International Tower Building; 700 fpm, 35.4 HP DC motor, empty car down acceleration. Ideal voltage and current should be illustrated as perfect sine waves. Note that the largest current harmonics are the fifth and seventh. This data is typical and would be identical for **any** 6-pulse SCR drive of **any** manufacturer.

The voltage waveform doesn't provide much information because it is very close to a sine wave. This is confirmed by measured Voltage Total Harmonic Distortion of 4.1% (THD Rms under the Voltage column). Note that voltage harmonics are insignificant on the bar graphs.

For a 6-pulse DC SCR drive, the main harmonics are five, seven, eleven, thirteen and so forth. Looking at the data table it is important to note that Current Total Harmonic Distortion is 26.9% (THD Rms under the Current column). The current magnitude (Imag) column shows the largest harmonic (fifth) as a percentage of the 60 Hz fundamental, or  $13.7 \text{ amps}/64.7 \text{ amps} = 21.2\%$ .

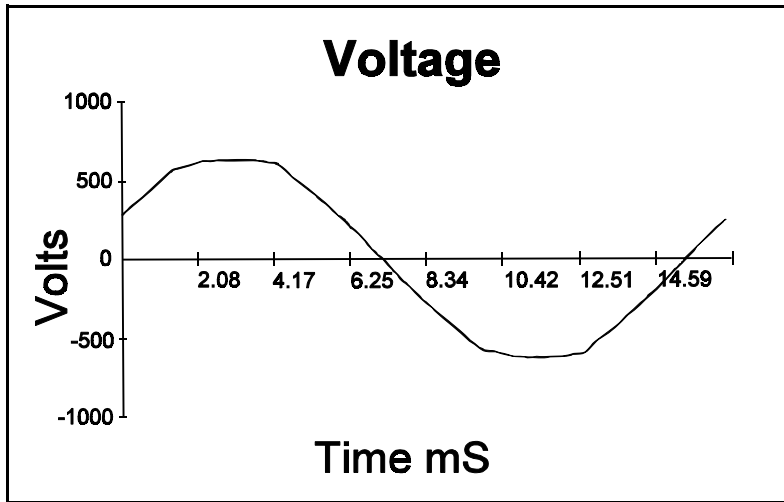
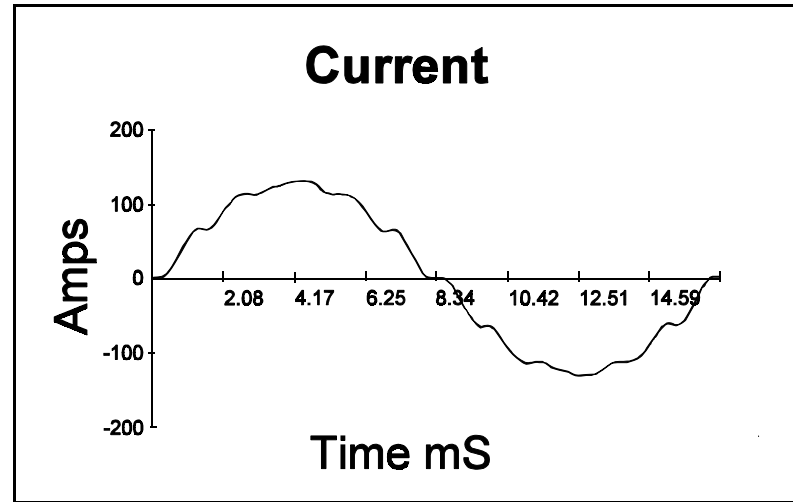
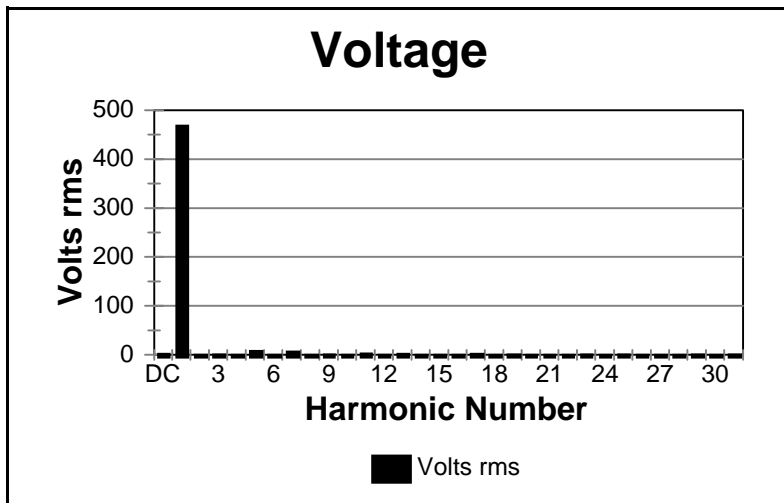
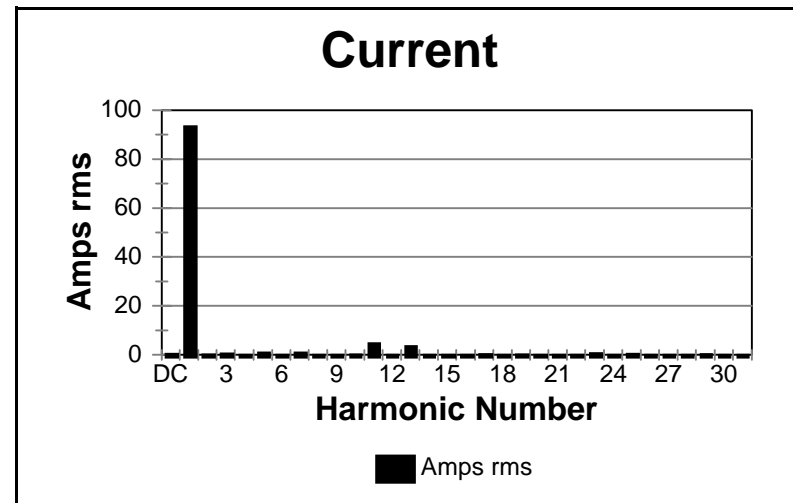
## 12-Pulse SCR Drive (MCE's "System 12")

Data taken from the Plaza Building; 500 fpm, 32 HP DC motor, empty car down acceleration. Ideal voltage and current should be illustrated as perfect sine waves. Note that the largest current harmonics are the eleventh and thirteenth.

As expected, the 12-pulse voltage waveform doesn't reveal any more information than the 6-Pulse voltage waveform because it also closely approximates a sine wave. The Voltage Total Harmonic Distortion confirms this, measured at only 2.5% lower than that of the 6-pulse DC SCR drive.

The *SYSTEM 12* current waveform more closely resembles that of an ideal sine wave than the waveform for the 6-pulse DC SCR. When the **current** harmonics are examined, one can see they are **greatly reduced** in comparison to the 6-pulse drive. The significant harmonics for the 12-pulse drive are 11, 13, 23, 25 and so forth.
